Manhole Inspection Summary

Manhole # S45E2_026MH

Insp Date: **1/25/08 11:22 AM**

Location Address: **Pascal Ave.**

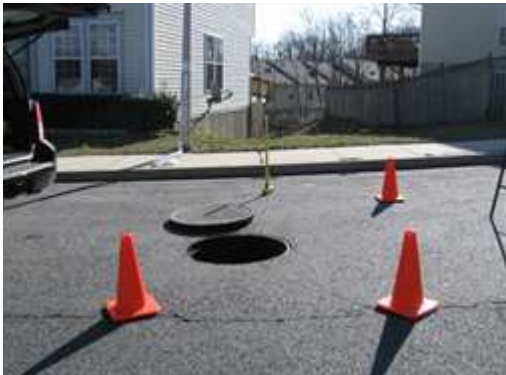
Location View

Pascal Ave.

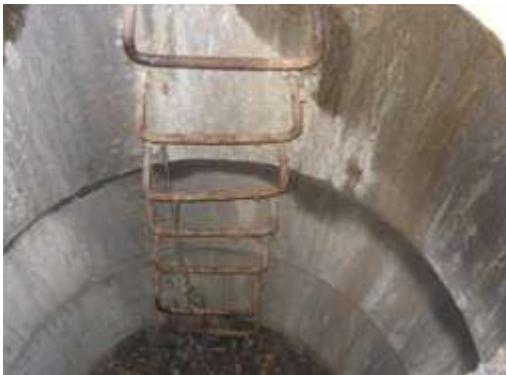
Steps Count: **7** Missing: **0** ☐ Corroded

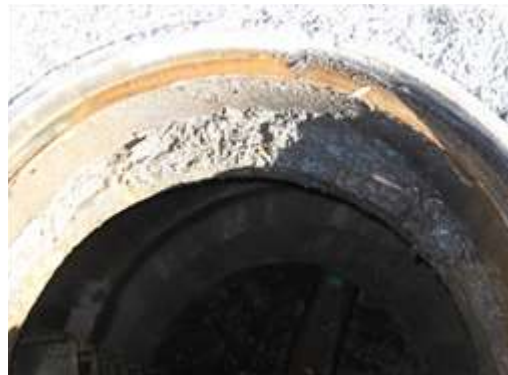
Defect 1

Frame Offset: **3** (in.) Condition: ☒ Sound ☐ Cracked ☐ Leaks

Frame offset

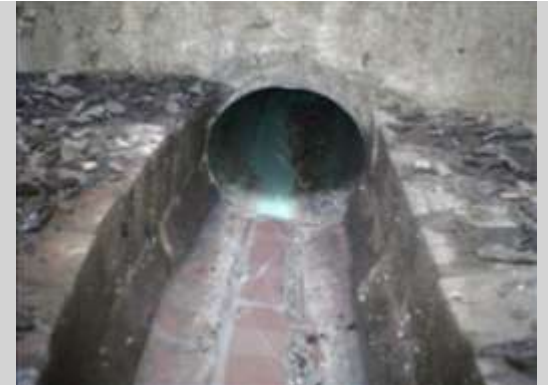
12 O'Clock Outflow

8 in. Circular Gravity Sewer
Pipe Out @ 12 O'Clock

Pipe Height: **8.4** (in.) Rod and Bar (Angled)
Pipe Material: **PVC** ☐ Pipe Lined
Invert Depth: **10.02** (ft.) Flow Characteristics: **Fast**
Deposits: ☒ None ☐ Mud ☐ Sludge ☐ Debris ☐ Grease
Silt Depth: (in.) Deposits Extent:
Infiltration: **None** Pipe Seal Cond: **Sound**

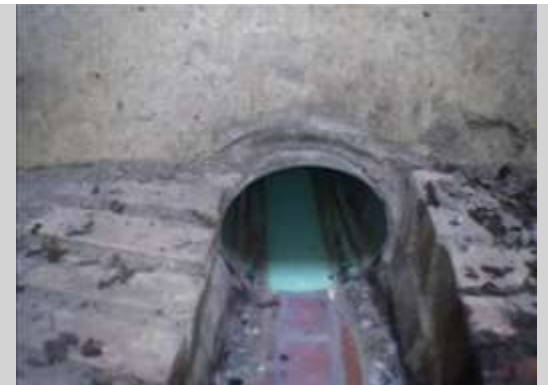
5 O'Clock Inflow

8 in. Circular Gravity Sewer
Pipe In @ 5 O'Clock

Pipe Height: **8.4** (in.) Rod and Bar (Angled)
Pipe Material: **PVC** ☐ Pipe Lined
Invert Depth: **9.97** (ft.) Flow Characteristics: **Fast**
Deposits: ☒ None ☐ Mud ☐ Sludge ☐ Debris ☐ Grease
Silt Depth: (in.) Deposits Extent:
Infiltration: **None** Pipe Seal Cond: **Sound**
